# Westside Marsh Emergency Overflow Channel Monitoring and Maintenance Plan (the “Plan”)

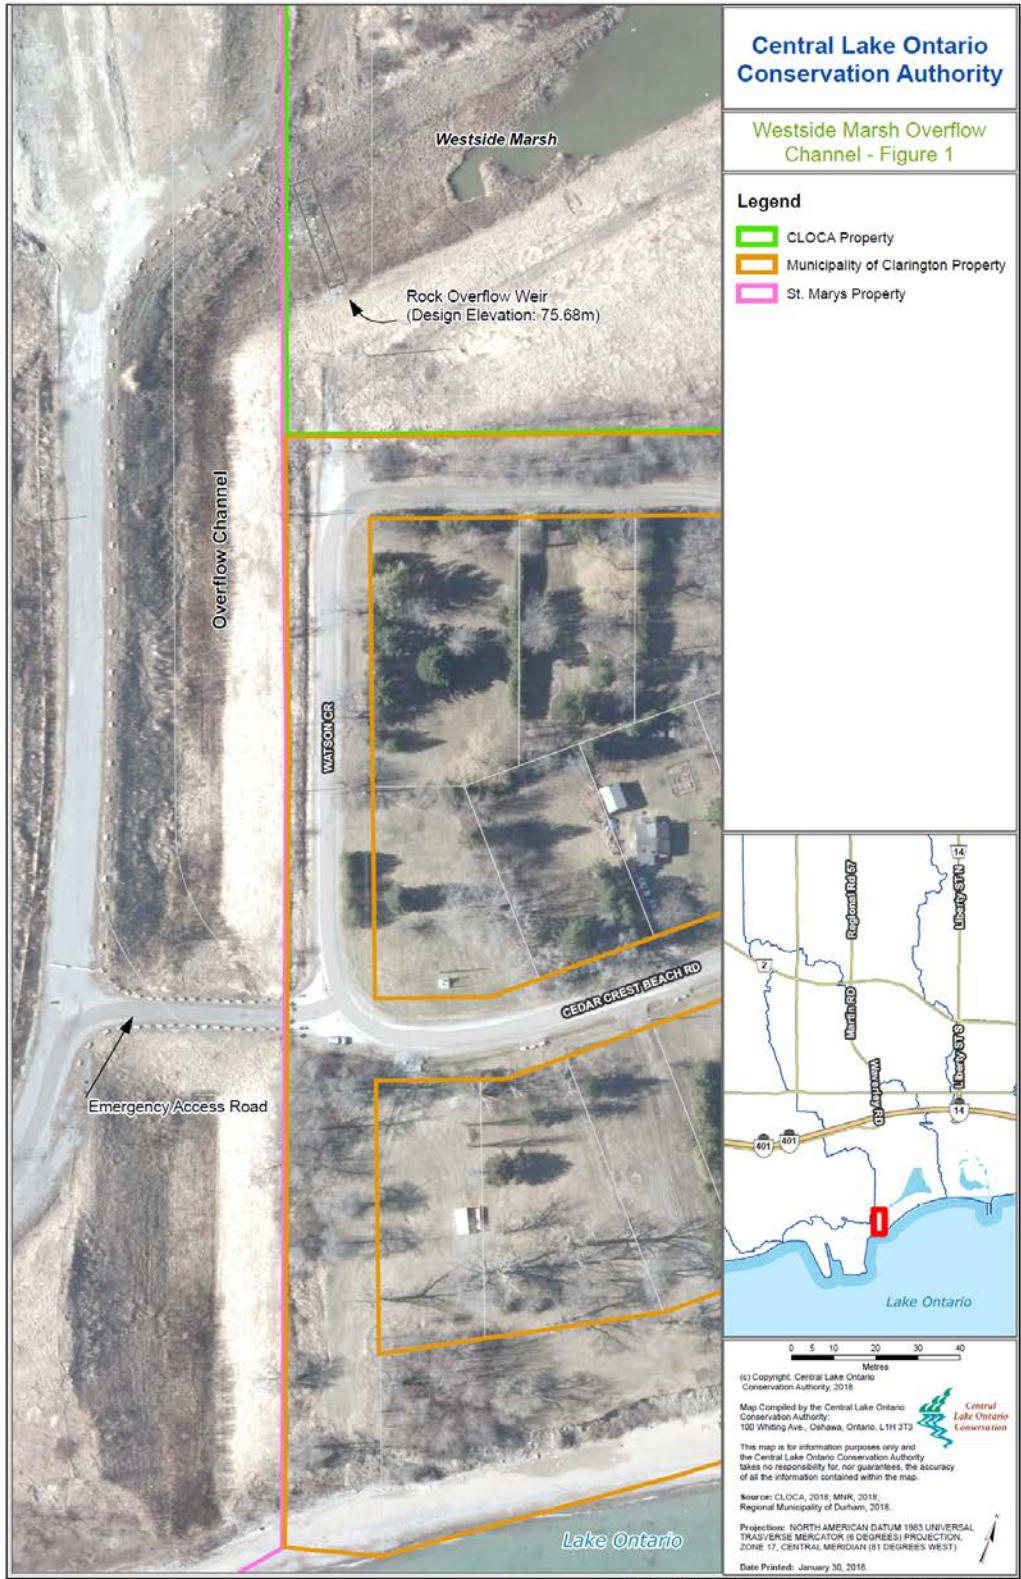
# Ownership Sketch

emergency overflow channel was approved by multiple agencies including CLOCA, Ontario Ministry of Natural Resources and the federal Department of Fisheries and Oceans. The emergency overflow channel was constructed in accordance with the approved designs under the direction of St. Marys, and remains in its ownership. The attached sketch shows the emergency overflow channel in relationship to the Westside Marsh and Lake Ontario, and the ownership of the various parcels.
