Hydrogeology and Hydrology Level 1 and 2 Study

Proposed Thomas Street Quarry Expansion, 4608 Perth Line 5, Perth South, ON

1781508-8000-R01-Rev1

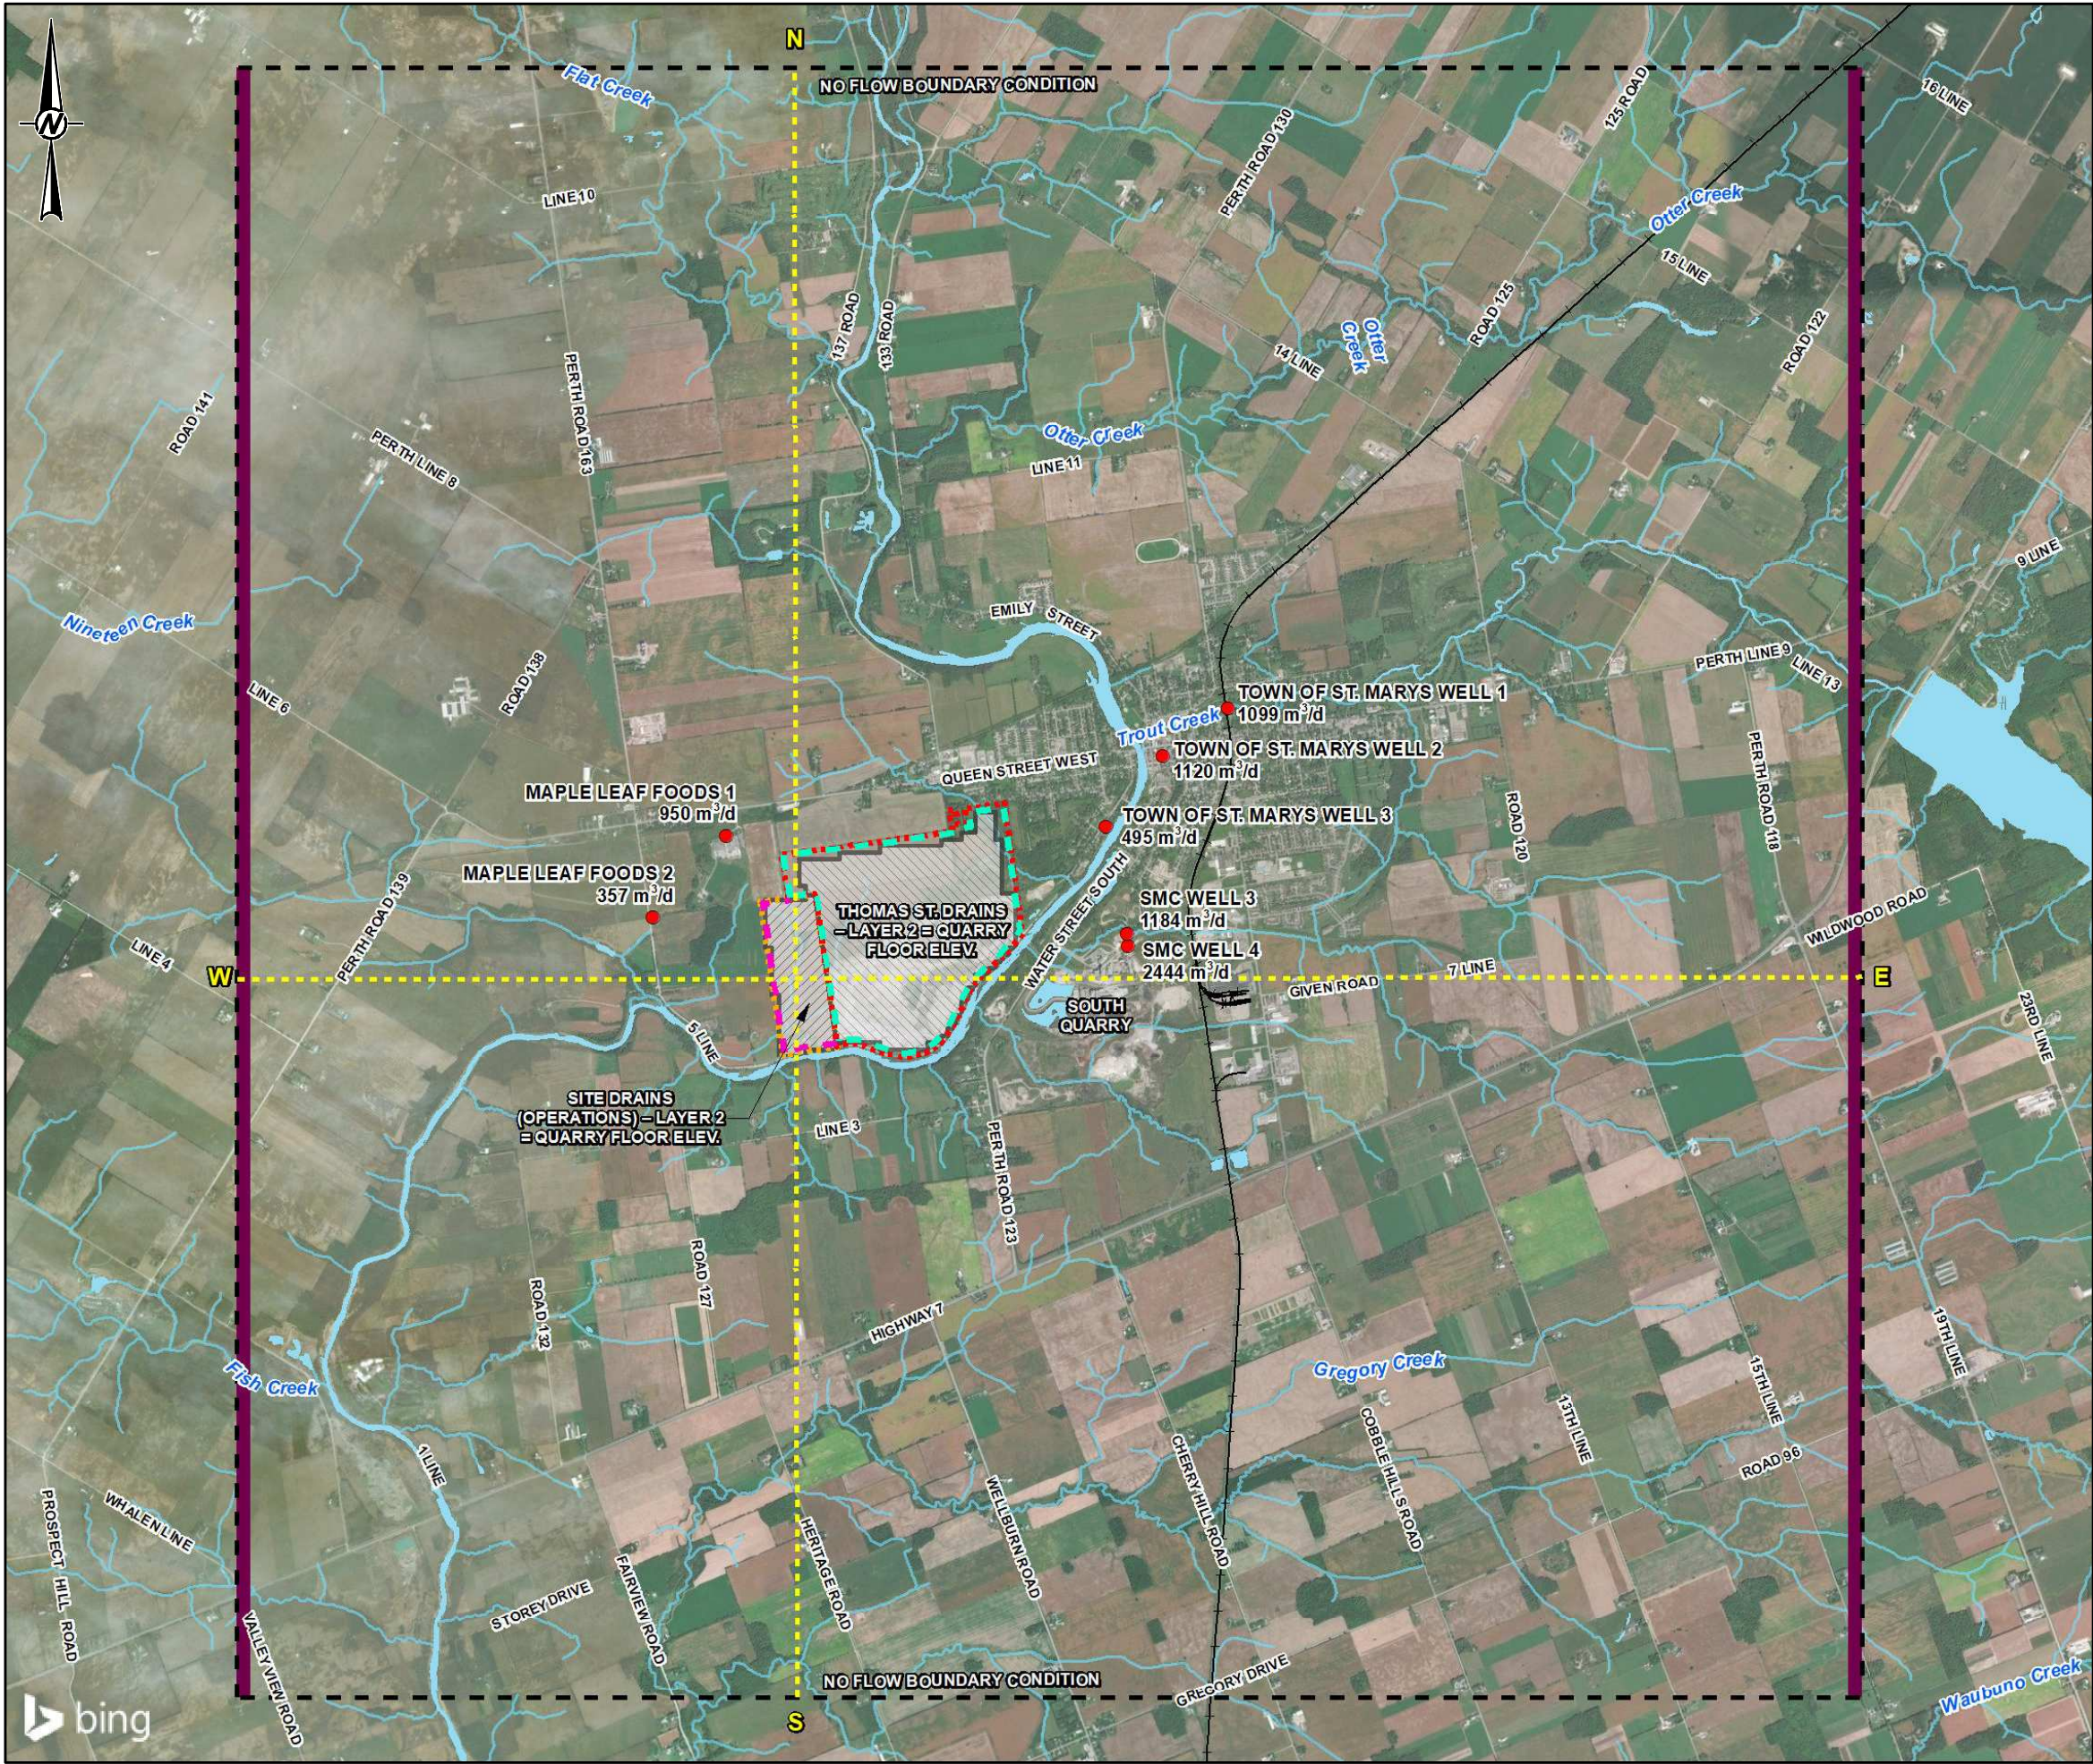
FIGURE
5.4

- Modelled Pumping Well and Pumping Rate
- Model Cross-Sections
- Railway
- Watercourse
- Waterbody
- Existing License Boundary (Thomas St. Quarry)
- Existing Limit of Extraction (Thomas St. Quarry)
- Proposed License Boundary
- Proposed Limit of Extraction
- Model Domain
- Constant Head Boundary Condition
